# Phoenix Lake Preservation and Restoration Project Update

February 16, 2021

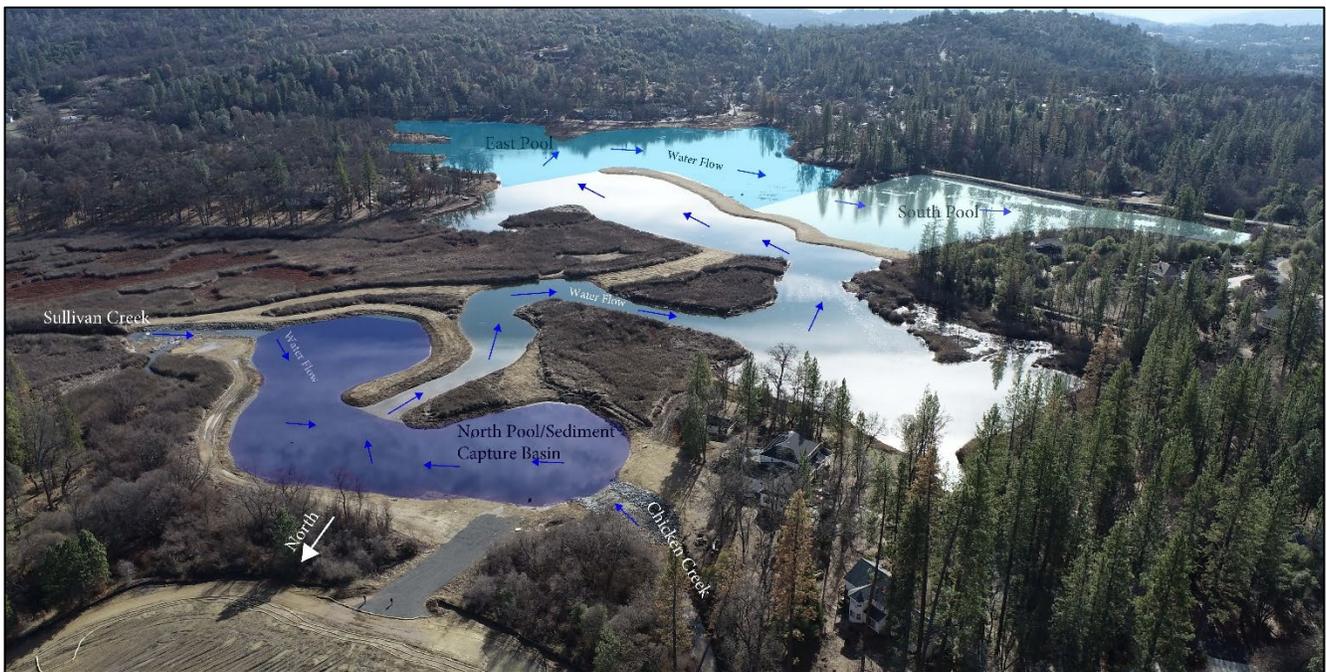
Picture to left: View of the Central Pool (lower left), East Pool (upper left), and water circulation berm (lower right to middle). The water circulation berm will be under water for more than half the typical year. The berm was engineered to promote water circulation, cooler water temperatures, and better water quality.

The project is a success and an improvement to our community's water supply, but success did not come without challenges. Access to the eastern portion of the lake (East Pool – see picture above), was hampered by wet conditions and soil types that made dewatering and conventional excavation impractical. To remove sediment in this area, a wet based hydraulic or mechanical dredging operation would need to be employed. Unfortunately, the cost to “wet” dredge greatly exceeds the District's remaining budget. The District will continue to investigate funding sources and construction methods that can be used to improve these areas in the future.

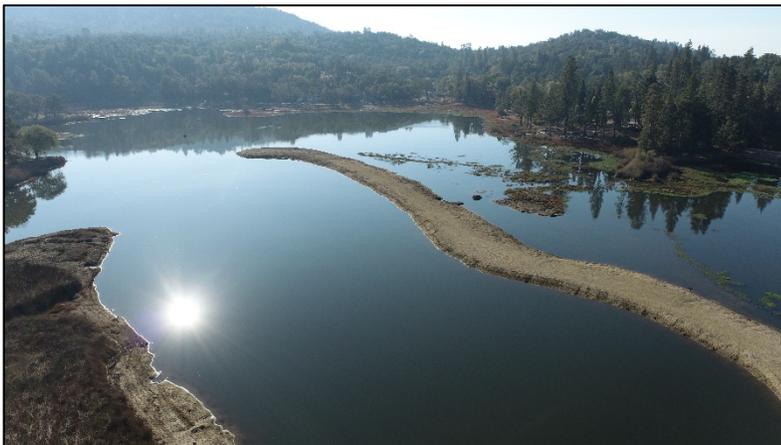
*Construction of the Sediment Capture Basin*

Most importantly, the sediment capture basin on the north side of the lake is now complete and operational. Absent the new sediment capture basin, sediment would continue to be broadcast throughout the lake and, over time, accumulate until the lake deteriorates to its former condition. The basin is critical to the on-going preservation of the lake.
